INVENTORY NO. 004

LOCATION: Main Substation

EQUIPMENT: North Cap. Bank Yard
Center Phase Buss-to-Underground Feeder
Connection.

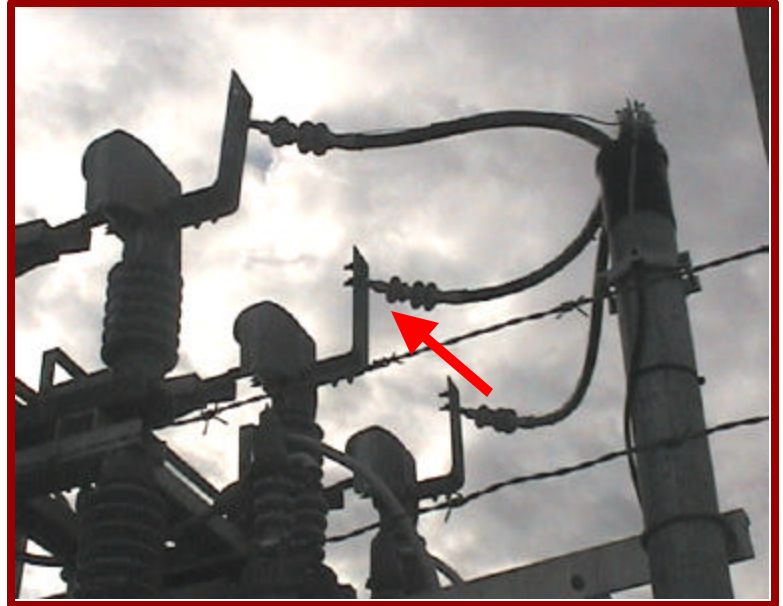
Visual Control Photo

FINDINGS: Suspect loose deteriorated Buss-to-
Underground Feeder Connection

RECOMMENDATIONS: Inspect, clean, and tighten
center phase buss connector and all related
components.

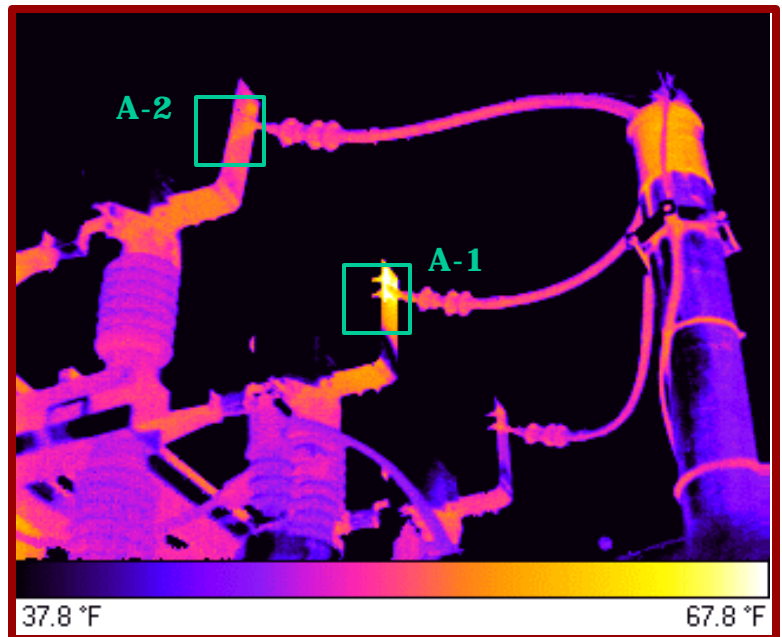
Thermal Infrared Exception Photo

EXCEPTION TEMP. (Area.1): 71F

REFERENCE TEMP. (Area 2): 50F

DELTA-T: 21F

PRIORITY 2

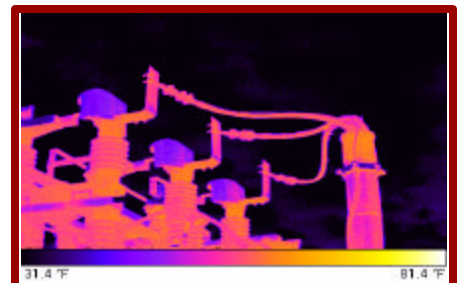
Notes: Normal Thermograph of South Bank
