The Scott Estate

Milan, OH

LOCATION: North End East Side (above porch)

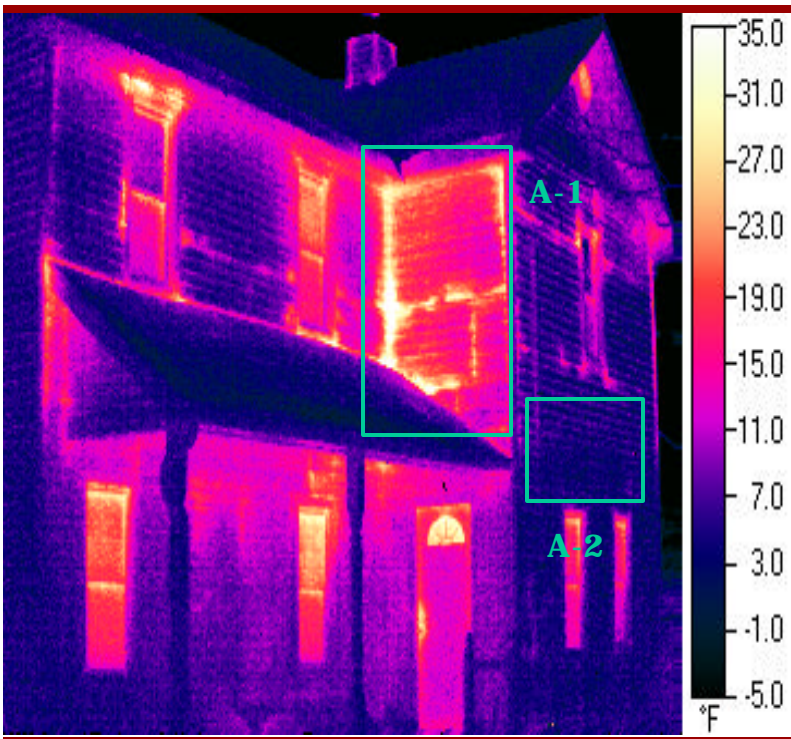
Thermal Infrared Exception Image

FINDINGS: Suspect Thermal Loss due to lack of insulation and/or excessive air flow.

EXCEPTION TEMP. (Area 1): 37F

REFERENCE (Normal) (Area 2): 12F

DELTA-T: 25F

PRIORITY 3

RECOMMENDATION: Further inspect the area of loss and repair as required.
