Avon Lake High School

Avon Lake, Ohio

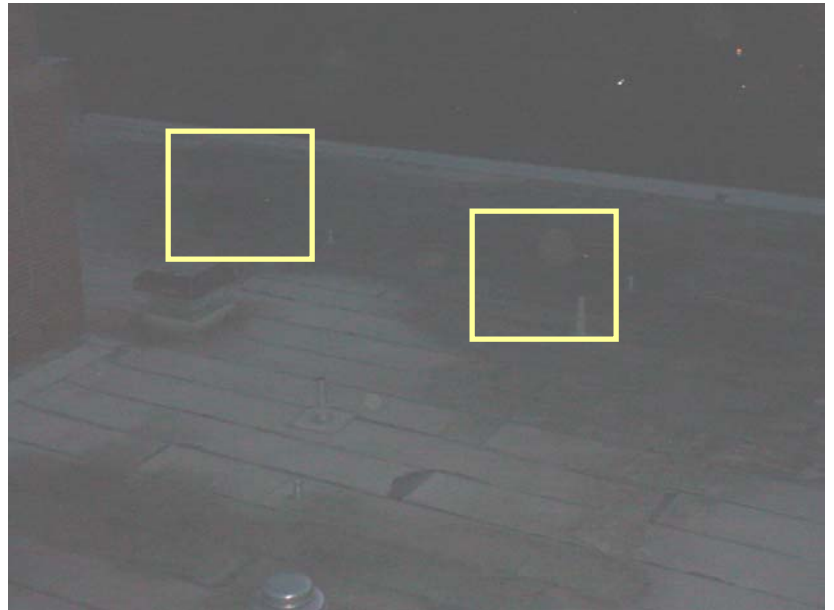
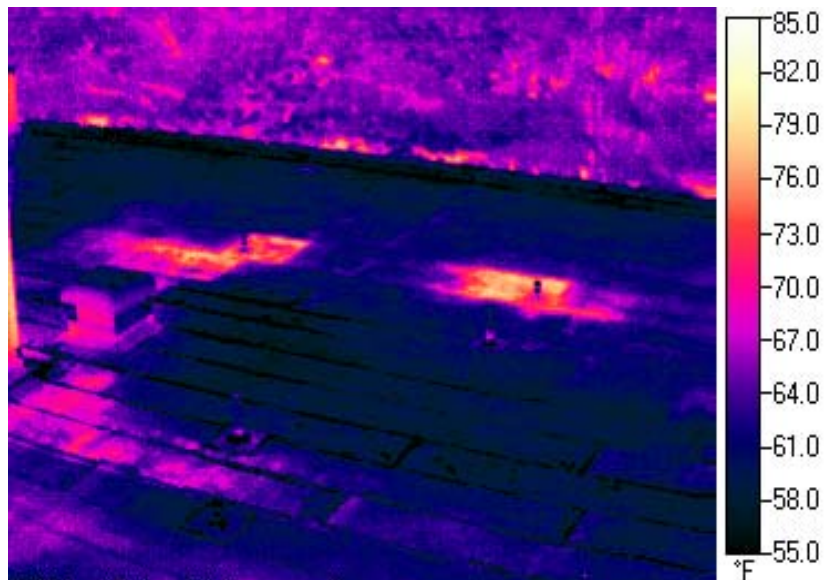
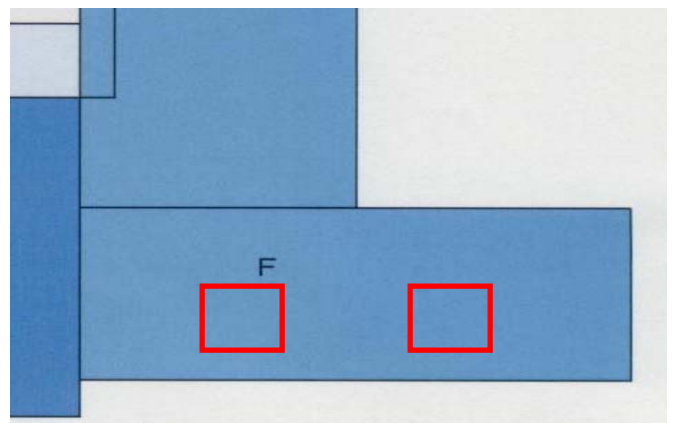
Roof Section: E

Suspect internal moisture saturation.

Based on all related information an internal core sample should be taken to confirm findings.

Notes: All moisture should be removed to eliminate internal damage to the deck and other internal structures

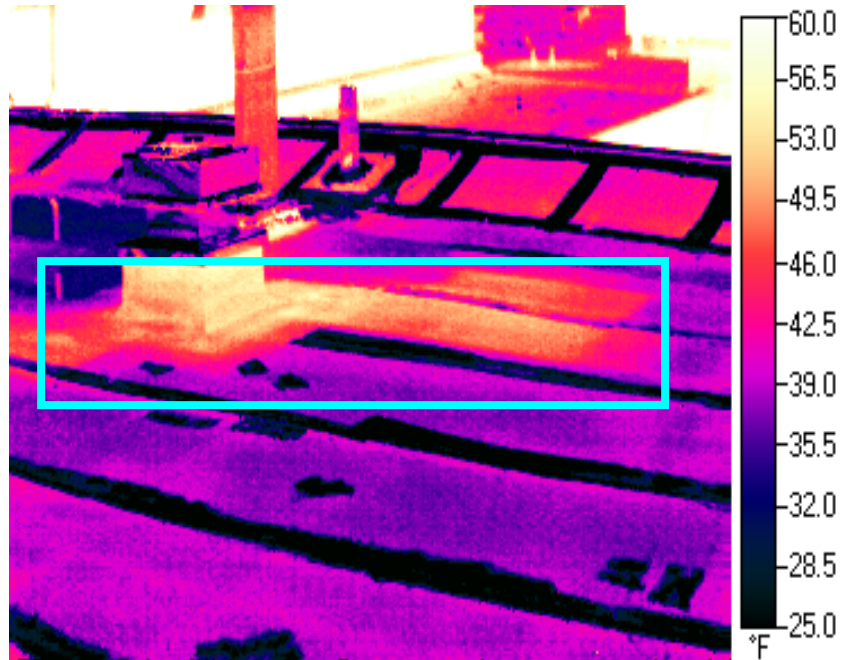
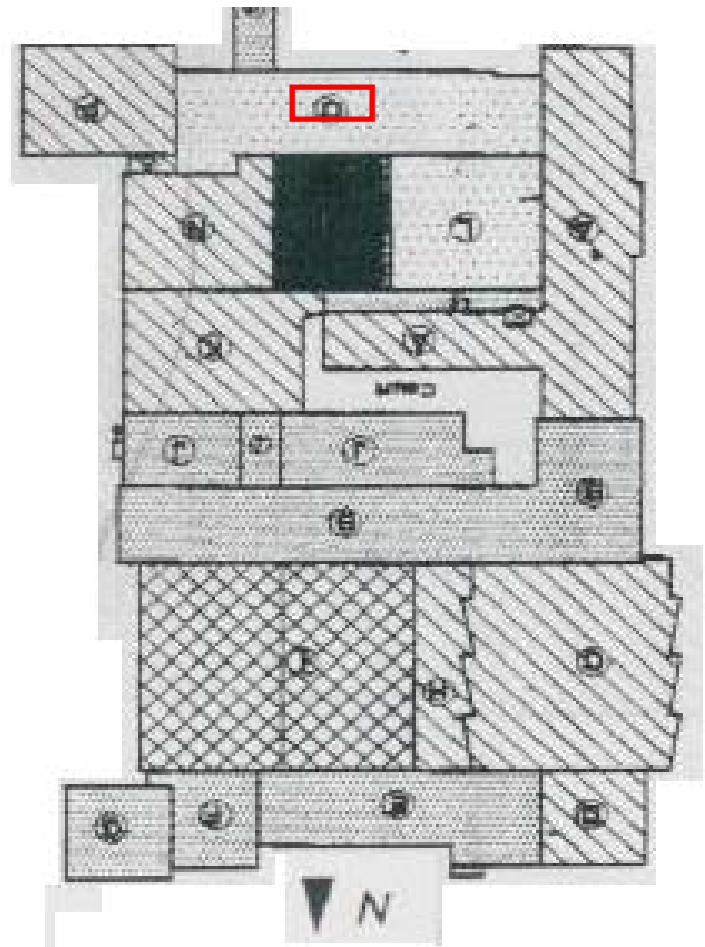
Roof Section: O

Survey Findings:
Suspect internal moisture
saturation.

Recommendations:
Based on all related
information an internal
core sample should be
taken to confirm findings.

Notes: All moisture
should be removed to
eliminate internal
damage to the deck and
other internal structures
