**INVENTORY No. 028**

**ADDRESS:** 2519 State Route 61  
Norwalk Plant

# Avon Lake High School

**Roof Section: E**

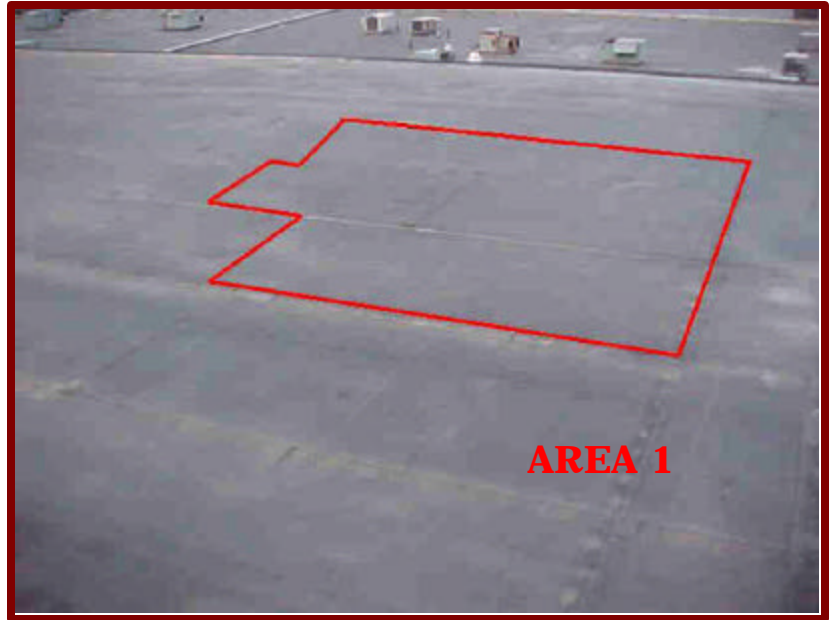
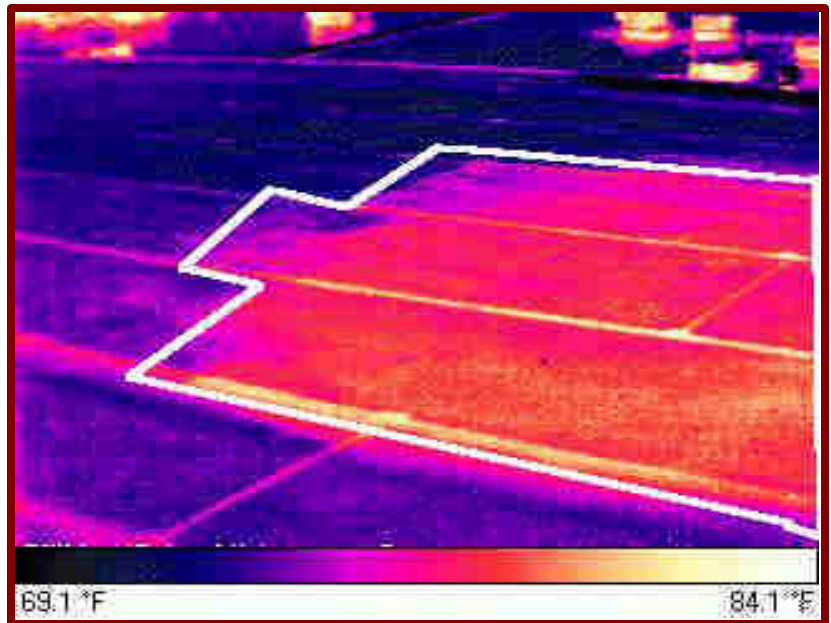
**EQUIPMENT:** Front Office (Area 1)

**FINDINGS:** Built-Up Construction

A continuous semi-flexible roof coverings of laminates, or piles, of saturated or coated felts alternated with layers of bitumen. Surfaced with asphalted materials.

**RECOMMENDATIONS:** Consult with an experienced roofing contractor to confirm results. (Core samples are suggested to confirm thermal analysis).

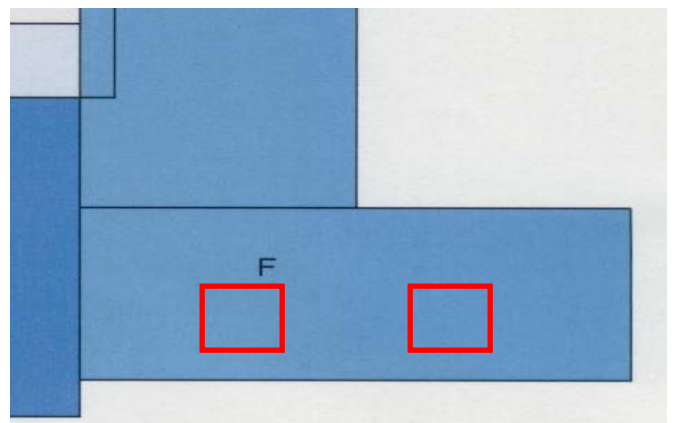
Suspect internal moisture saturation.

Based on all related information an internal core sample should be taken to confirm findings.

**Notes:** All moisture should be removed to eliminate internal damage to the deck and other internal structures

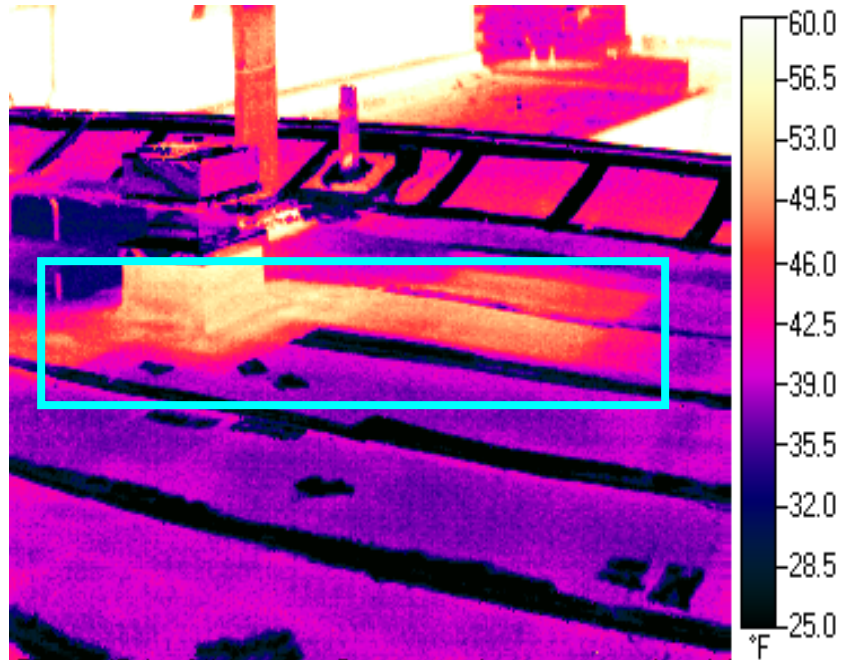
**Roof Section:** O

**Survey Findings:**  
Suspect internal moisture  
saturation.

**Recommendations:**  
Based on all related  
information an internal  
core sample should be  
taken to confirm findings.

**Notes:** All moisture  
should be removed to  
eliminate internal  
damage to the deck and  
other internal structures
