ABC Corporation

INVIZIONS, Inc.
Predictive Maintenance Services

VIBRATION ANALYSIS

Report Index: January 1, 2023

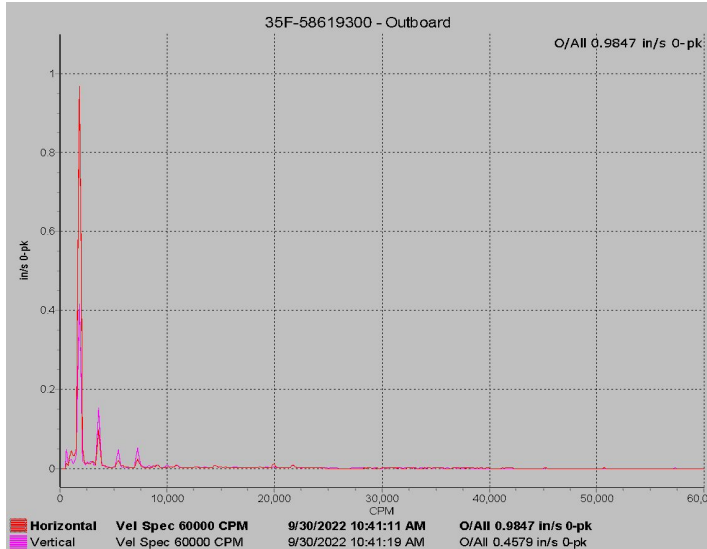
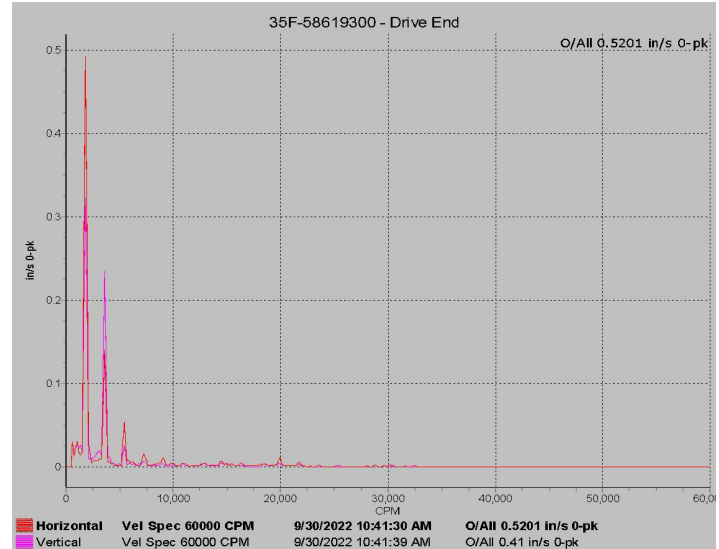
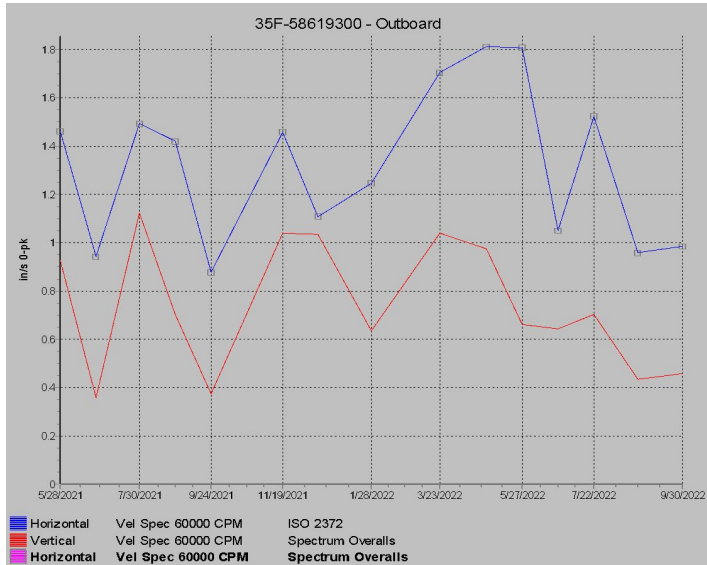
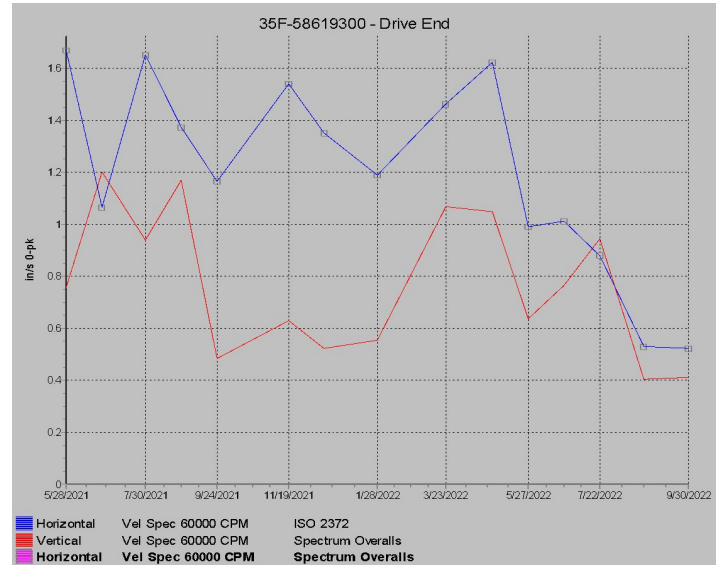
Findings: Although amplitudes have decreased, amplitudes remain elevated throughout motor and indications of a mass unbalance on motor and/or fan blades is present throughout unit.

Recommendations: Schedule motor and fan blades for inspection and balancing immediately.

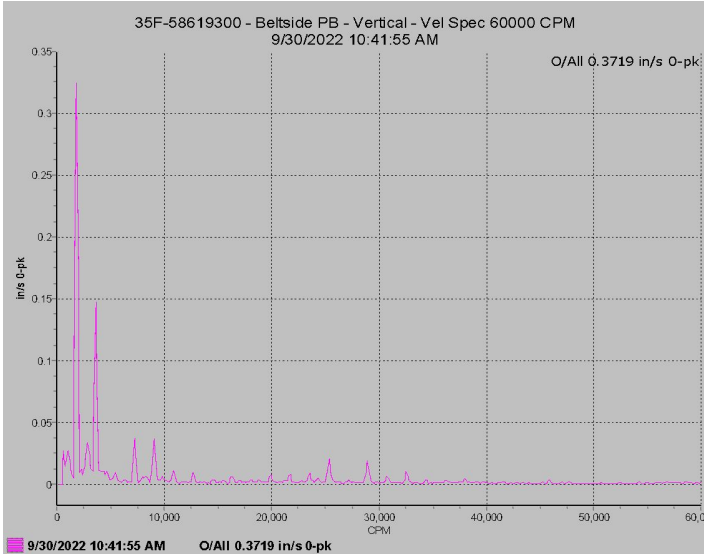
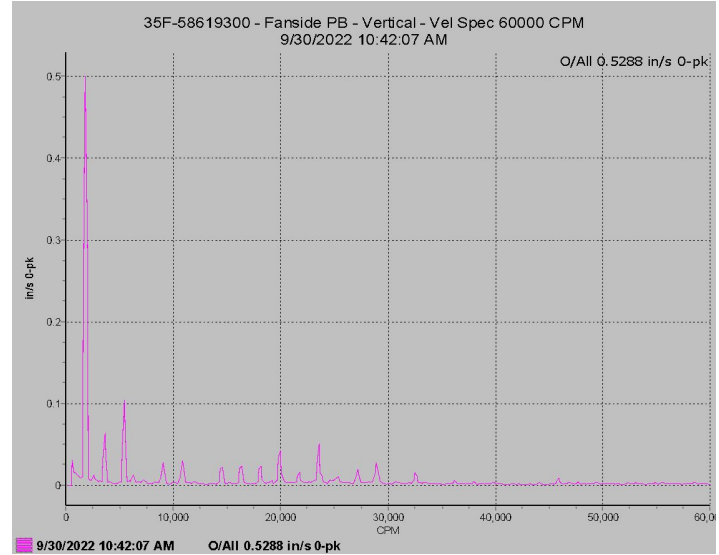
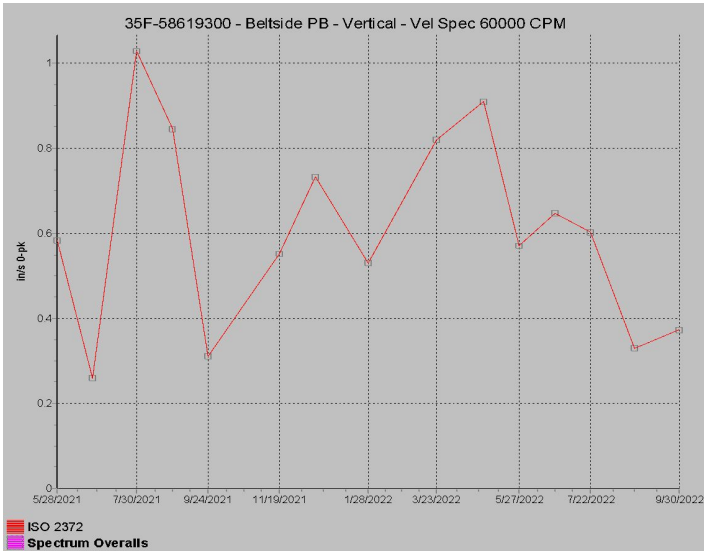
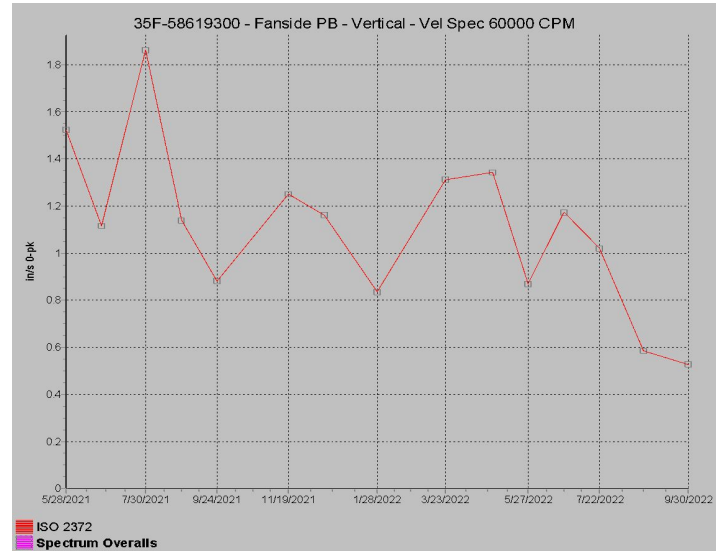
Findings: Although amplitudes have decreased, amplitudes remain elevated throughout motor and indications of a mass unbalance on motor and/or fan blades is present throughout unit.

Recommendations: Schedule motor and fan blades for inspection and balancing immediately.

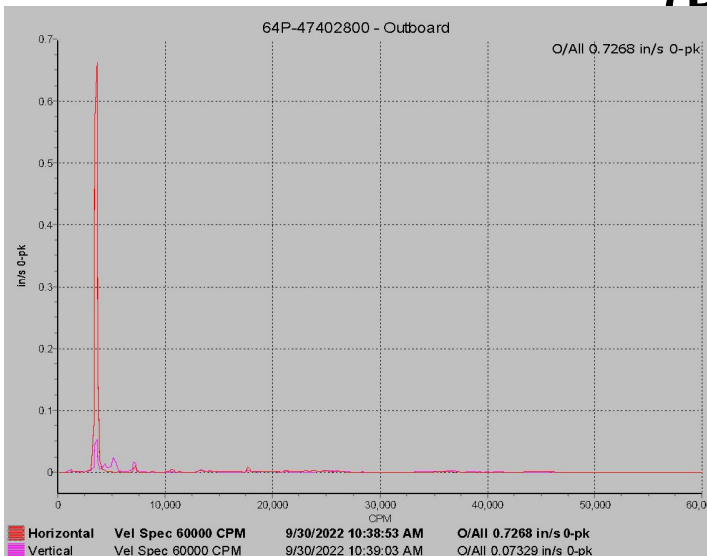
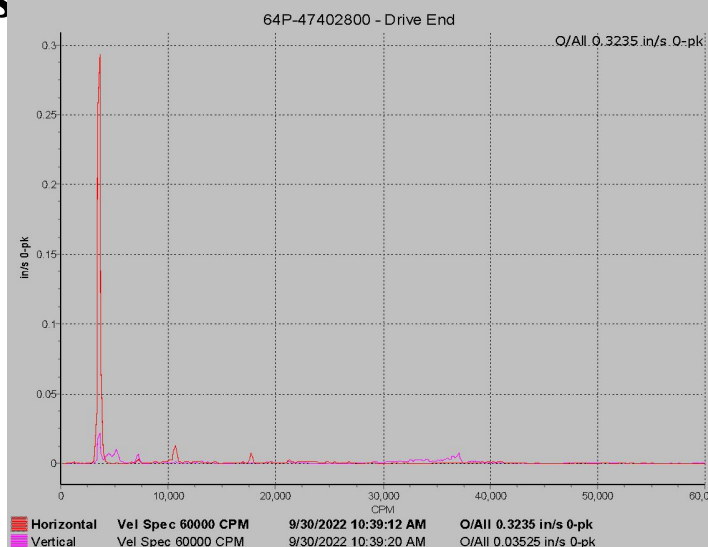
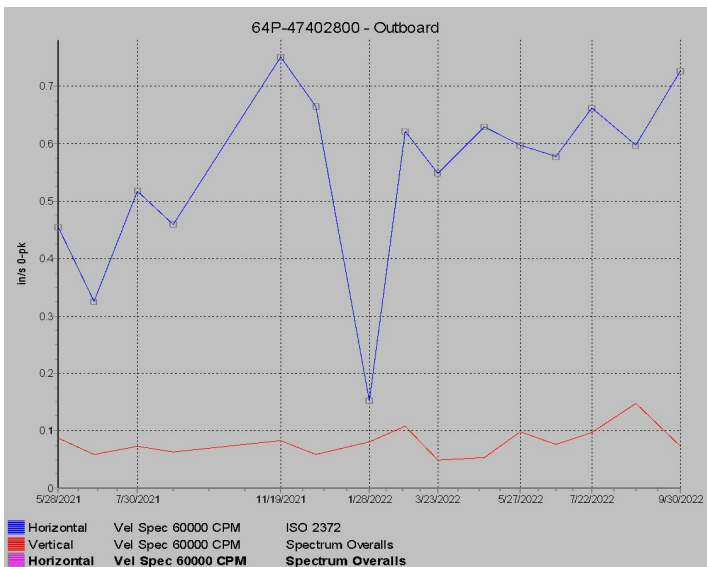
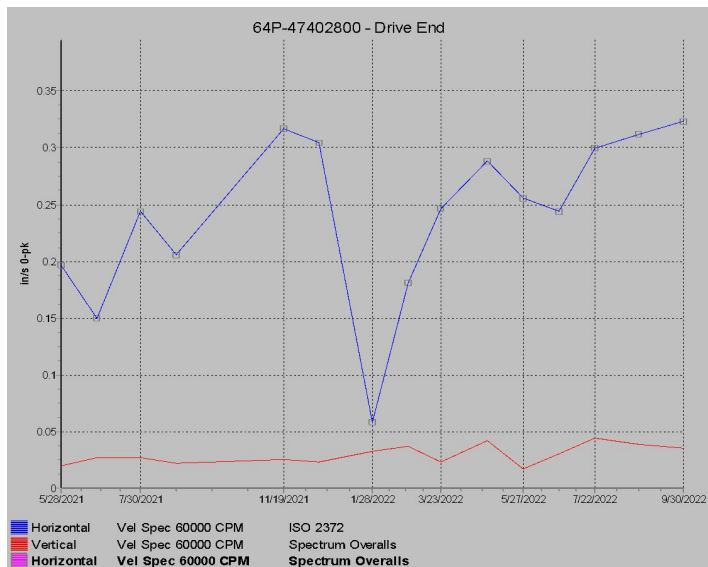
Findings: Amplitudes have remained elevated at both motor horizontal collection points and indications of possible mass unbalance on motor and/or possible coupling misalignment are present.

Recommendations: Schedule unit to be pm'd, balanced and aligned.

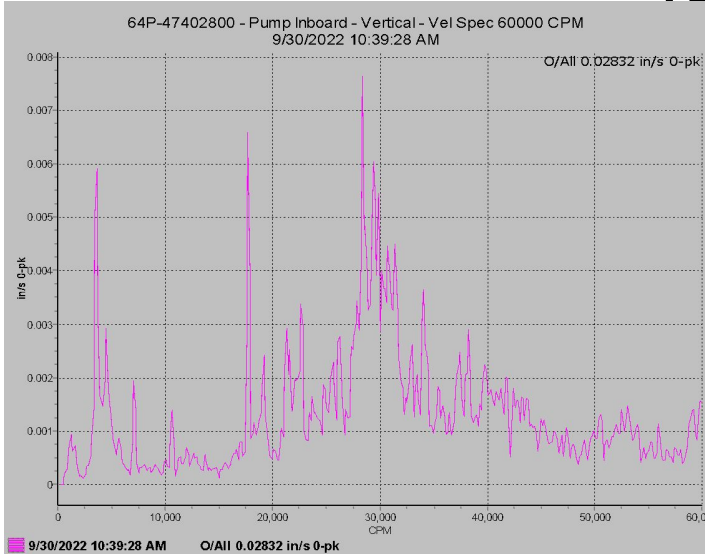
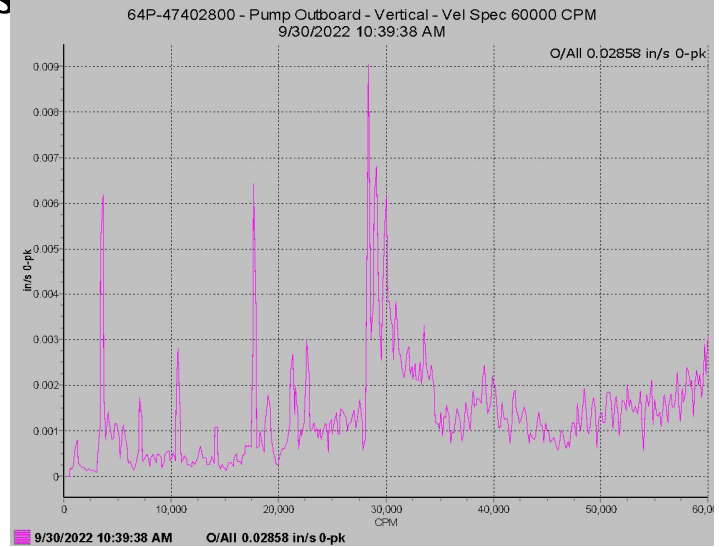
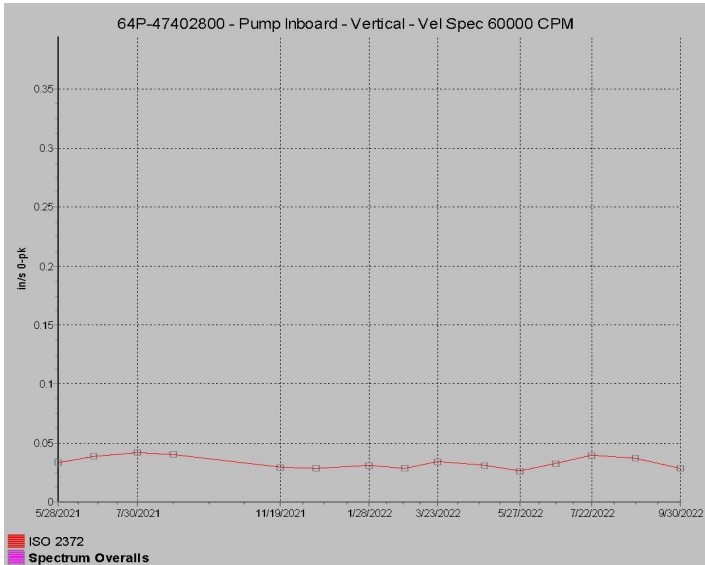
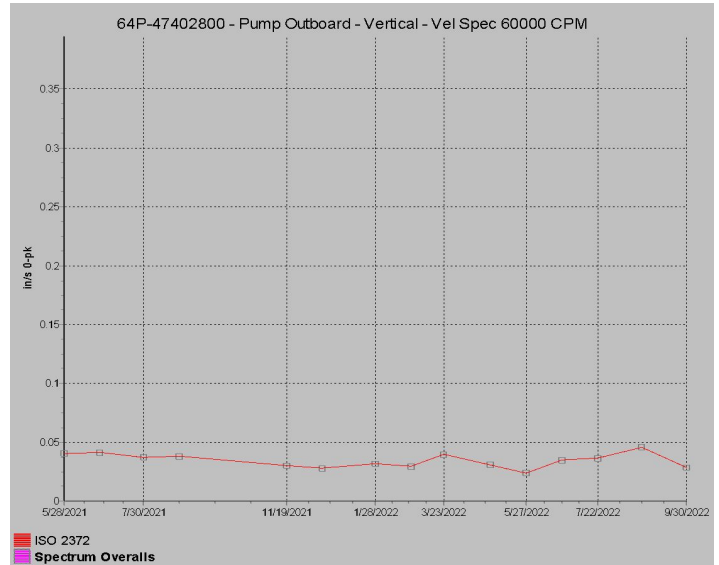
Findings: Amplitudes have remained stable throughout pump and remain relatively low and within acceptable parameters for this equipment.

Recommendations: Continue to monitor via periodic vibration data collection and analysis.

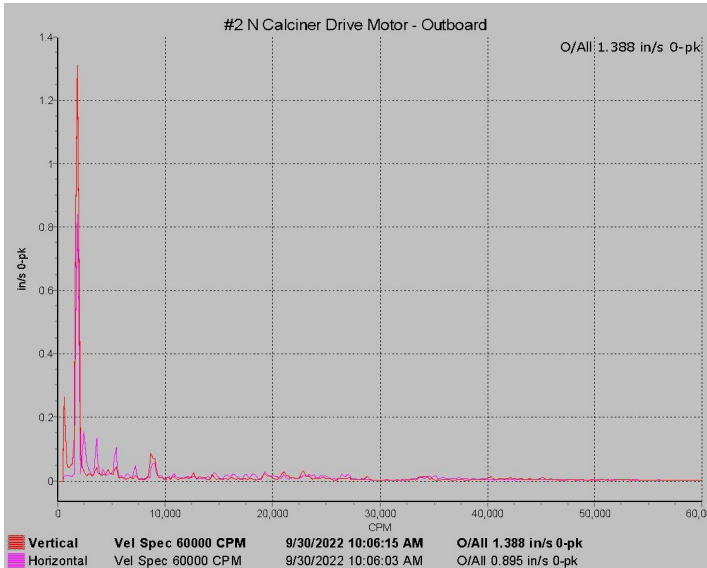
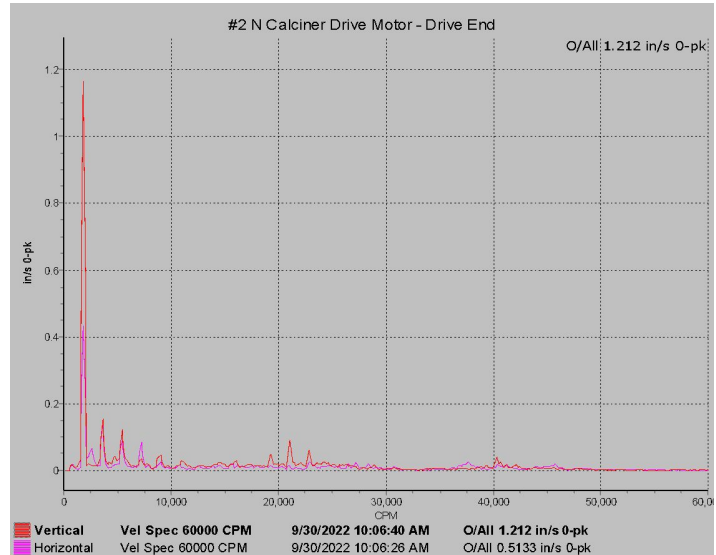
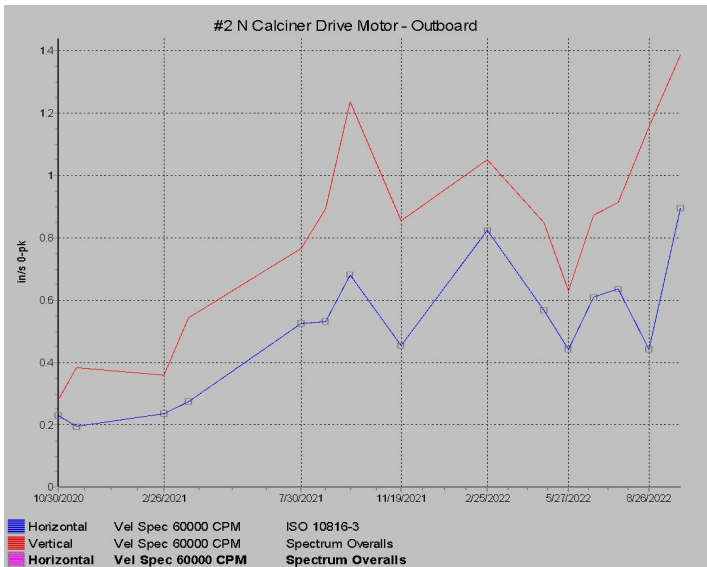
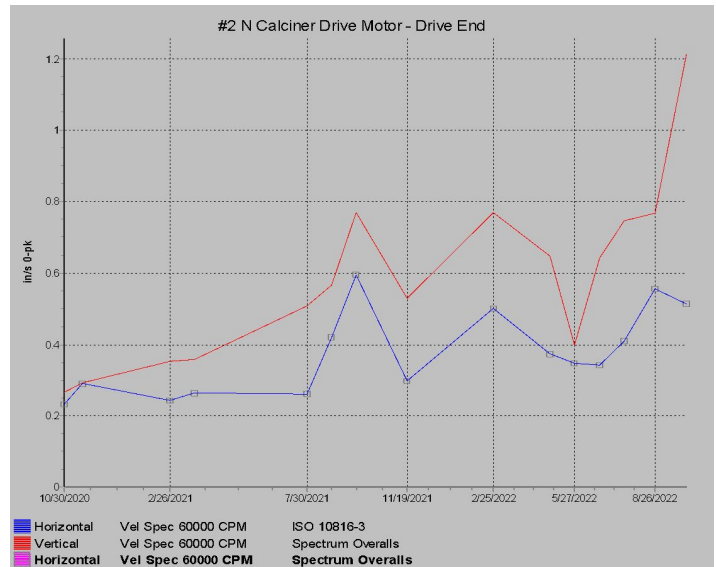
Findings: Amplitudes have remained elevated or have increased throughout motor and indications of bearing defects are present at this time.

Recommendations: Schedule unit to be inspected for bearing damage and possible motor replacement.

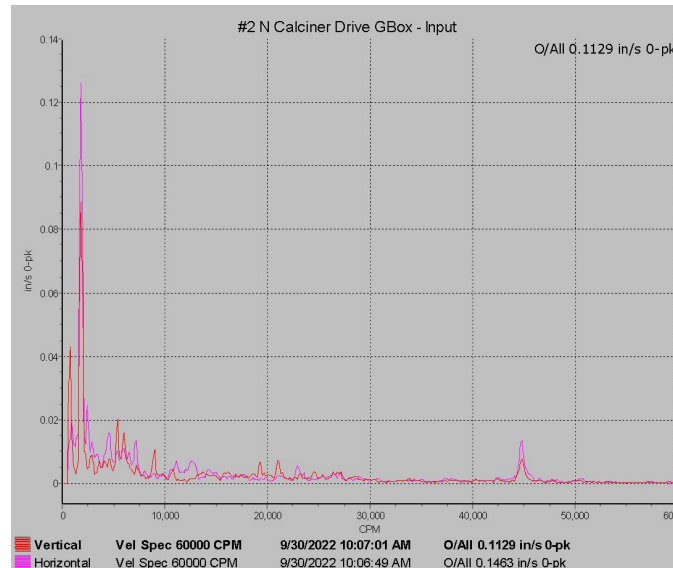
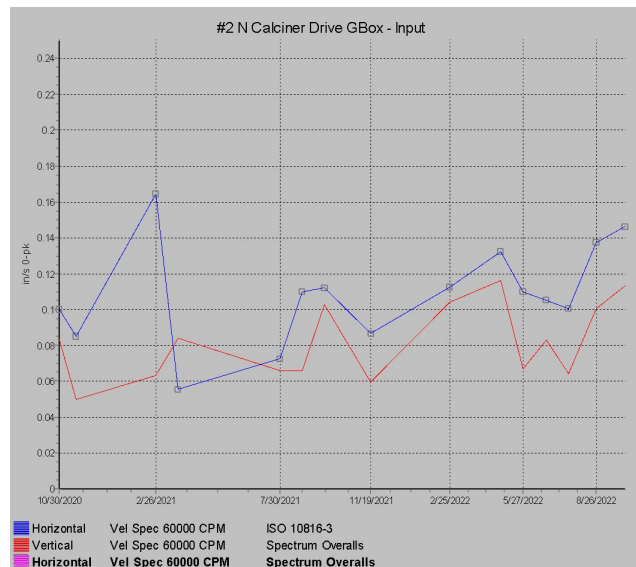
Findings: Amplitudes have remained fairly stable at the gearbox input collection points and data collected at this time remains within acceptable parameters for this equipment.

Recommendations: Continue to monitor via periodic vibration data collection and analysis.

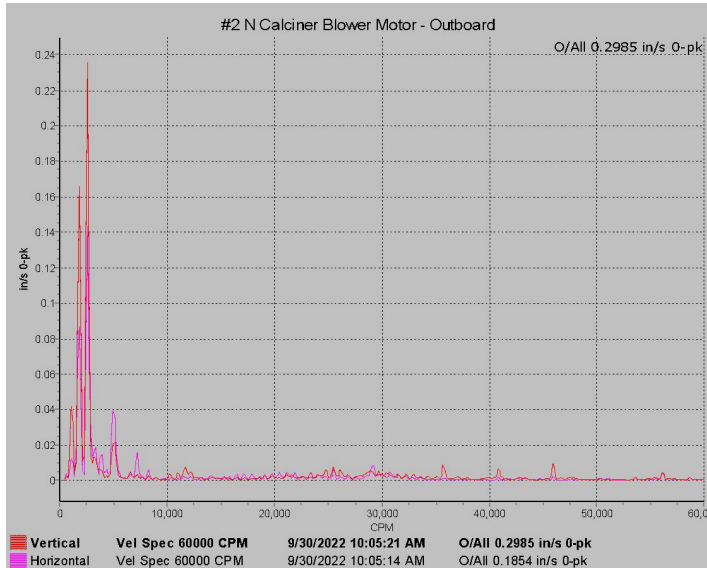
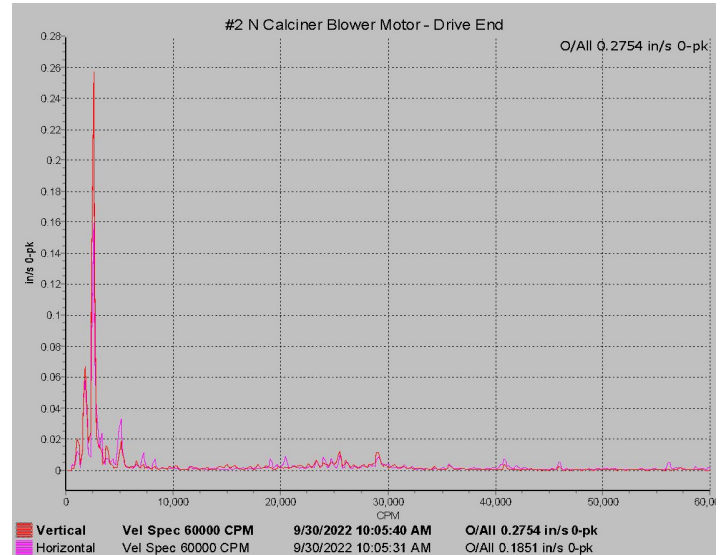
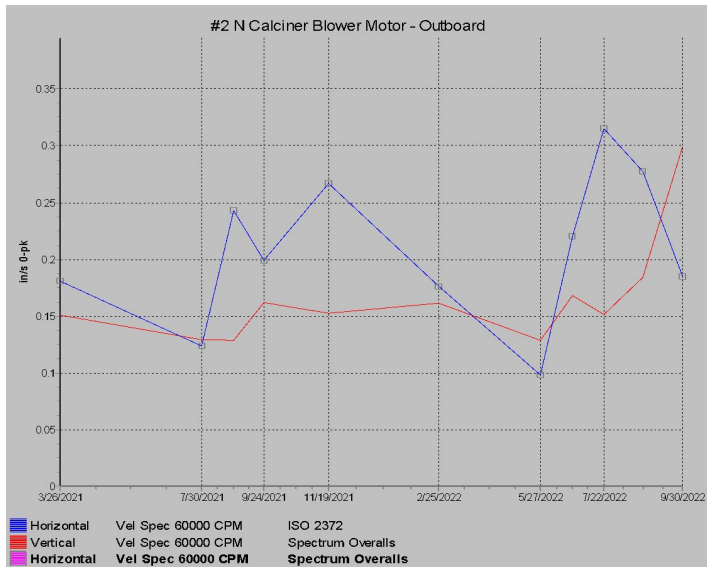
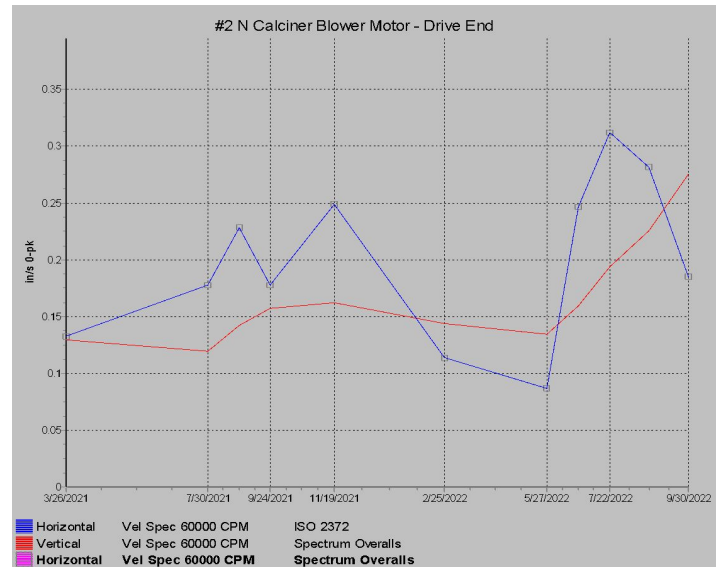
Findings: Although slightly elevated, amplitudes remain within acceptable parameters for this equipment.

Recommendations: Continue to monitor via periodic vibration data collection and analysis.
