## INVENTORY No. 024

**LOCATION:** Main Office Building

**EQUIPMENT:** Panel LRMA Main Disconnect  
Right Phase Top Fuse Holder

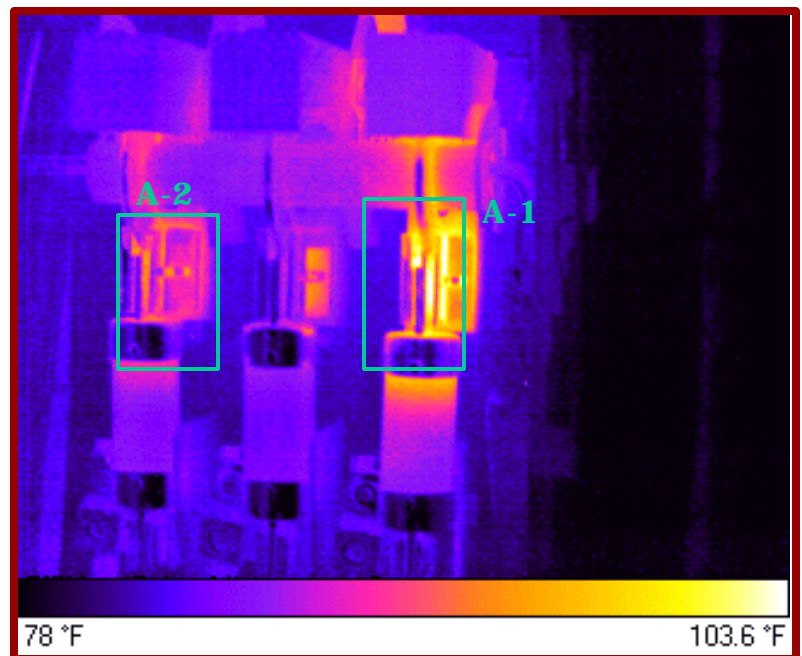
**Thermal Infrared Exception Photo**

**FINDINGS:** Suspect loose deteriorated fuse holder components and contacts.

**EXCEPTION TEMP. (Area.1):** 107F

**REFERENCE TEMP. (Area 2):** 85F

**DELTA-T:** 22F

### **PRIORITY RATING: (NETA STANDARDS)**

*Indicates probable deficiency; repair as time permits.*

**PRIORITY 2**

**RECOMMENDATIONS:** Inspect, clean, and tighten fuse assembly and related components. Replace fuse and components if required.
